**REPORT TO BOARD OF DIRECTORS OF
GENERAL MOTORS COMPANY
REGARDING IGNITION SWITCH RECALLS**

May 29, 2014

Anton R. Valukas

JENNER & BLOCK

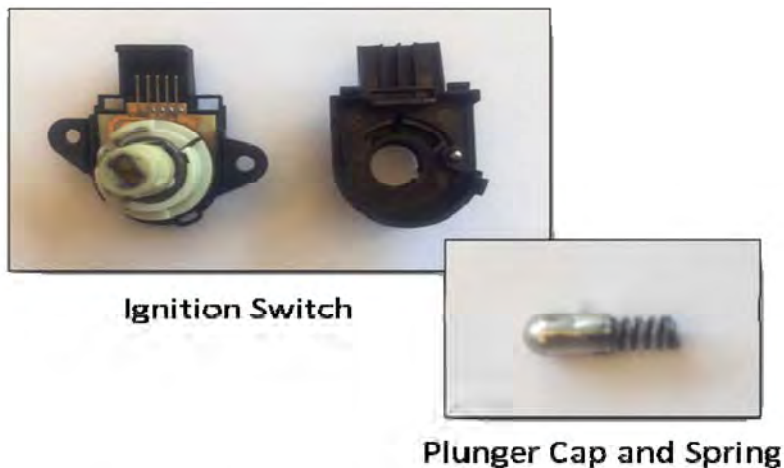
Components within the Ignition Switch control the amount of effort required to turn the switch from one position to another. A plunger cap and coiled spring inside the Ignition Switch sit in a small groove called a “detent,” which holds the switch in the position to which the driver turns the key: Off, Run, Accessory, or Crank. The driver rotates the key by applying a certain amount of torque to overcome the detent, thereby rotating the switch out of one position and into another. One method to increase the effort required to rotate the Ignition Switch from one position to another is to use a longer and more tightly coiled spring.

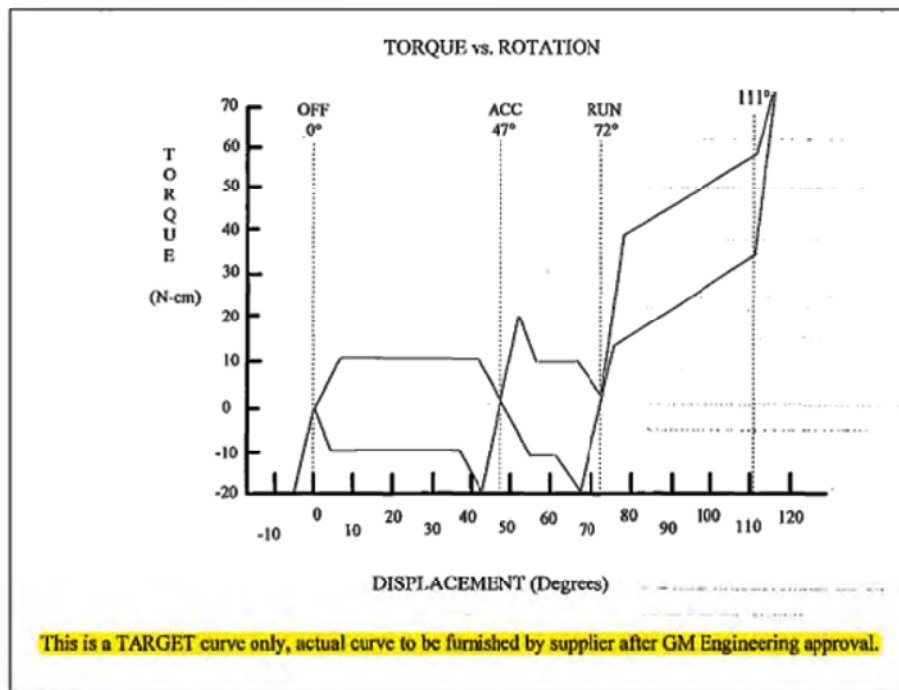
cm”) as the torque needed to turn the ignition from Run to Accessory.¹¹⁰ As noted below, the target curve indicated that the “actual curve [was] to be furnished by [the] supplier after GM Engineering approval.”¹¹¹

Section 3.2.2.3 described the desired feel of the switch – “smooth, with clearly defined detents” – and also provided that “[f]inal switch tactile feel is subject to GM Engineering approval.”¹¹² The Specification was revised in 1998 and 1999, without changes to the parameters for the torque required to rotate from Run to Accessory.¹¹³

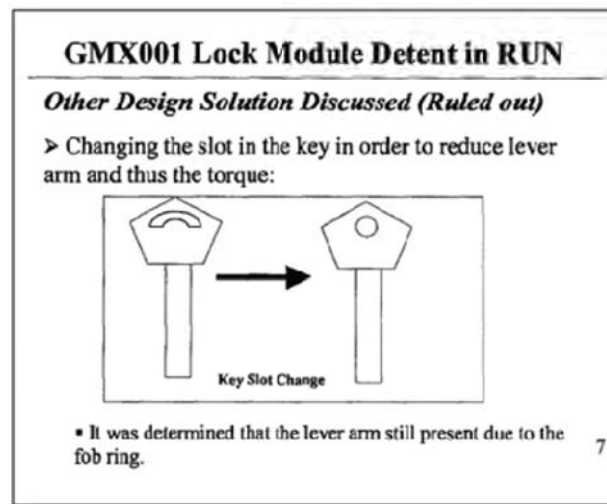
The presentation also included some “Ruled Out” solutions, including changing the design of the key head from a slot to a hole – a solution GM personnel ultimately pursued. With a slot design, the key ring could move up and down in the slot. If the key ring contained extra weight, that movement could exert torque on the Ignition Switch and, combined with other circumstances, move it from Run to Accessory. Keeping the key ring in the center of the key (through a hole design) would prevent such movements.²⁶¹ The estimated cost to make the key change was \$70,000 for tooling for a new key head, \$400,000 to modify production assembly equipment, and a piece price increase of \$0.50 per vehicle.²⁶²

The presentation to the CPIT also described a “Sure Solution” to fix the problem: change the location of the Ignition Switch on the steering column from a low-mount to a higher mount.²⁶³ According to David Trush, the Lead Design Engineer on the ignition cylinder, the

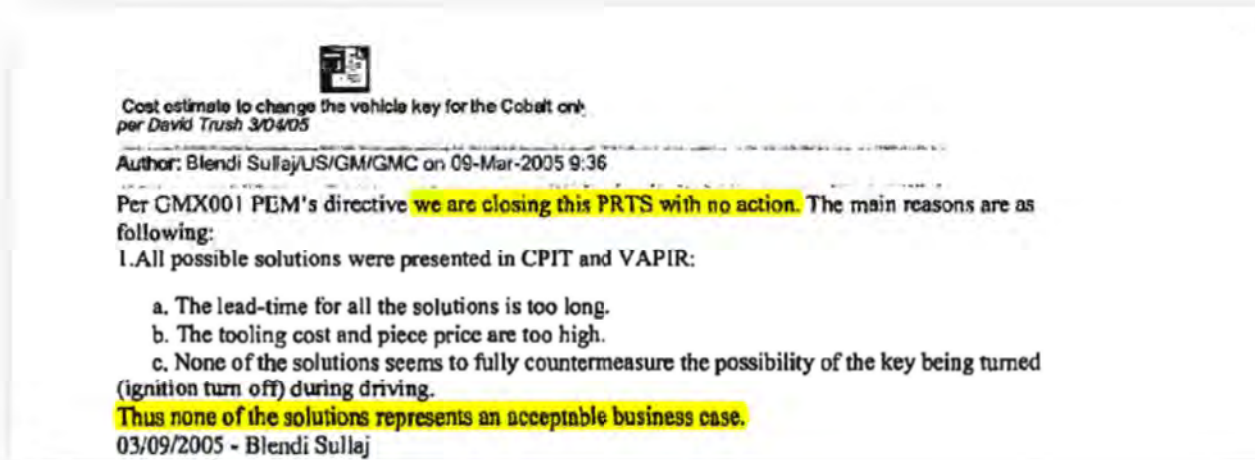
As shown above, the November 19, 2004 PRTS stated that “none of the solutions represents an acceptable business case” – a standard phrase used by GM personnel for closing a PRTS without action.²⁷¹ David Trush, the lead engineer on the ignition cylinder, explained that to present an “acceptable business case,” a solution should solve the issue, be cost effective, and have an acceptable lead time to implement the change.²⁷² In this case, according to Trush, the proposed changes were not implemented because none of them was guaranteed to resolve the problem completely.²⁷³ Lori Queen confirmed that a discretionary, or non-safety related, part change had to clear a series of financial hurdles before it would be approved.²⁷⁴ Engineers who proposed a discretionary change had to make out an “acceptable business case” before the

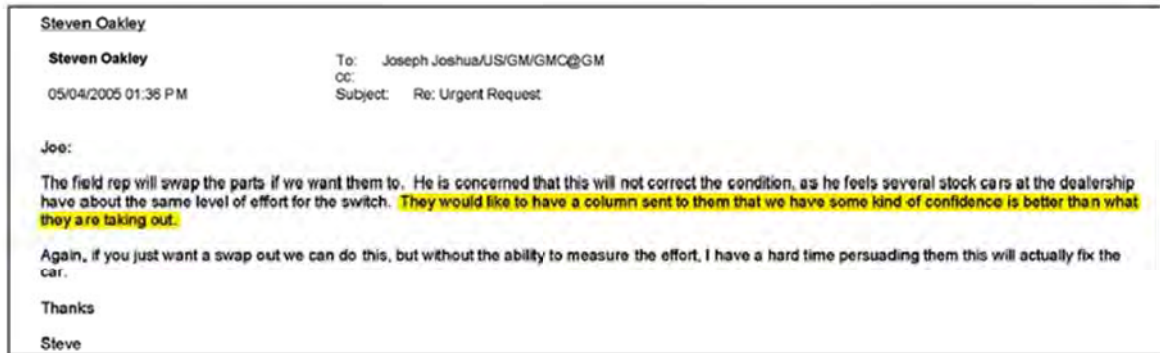
The field rep will swap the parts if we want them to. He is concerned that this will not correct the condition, as he feels several stock cars at the dealership have about the same level of effort for the switch. They would like to have a column sent to them that we have some kind of confidence is better than what they are taking out. Again, if you just want a swap out we can do this, but without the ability to measure the effort, I have a hard time persuading them this will actually fix the car.³¹¹

DeGiorgio was one of the GM personnel who received this e-mail chain, which effectively stated that the customer’s car, as well as others at the dealership, had Ignition Switches with insufficient torque and, at least in the customer’s situation, appeared to cause the car to shut off while driving.³¹² For his part, DeGiorgio claims not to recall the e-mail exchange. DeGiorgio also claims that at this time he still had not received any complaints about the Ignition Switch in the Ion, which had the same Ignition Switch and had been in production since MY

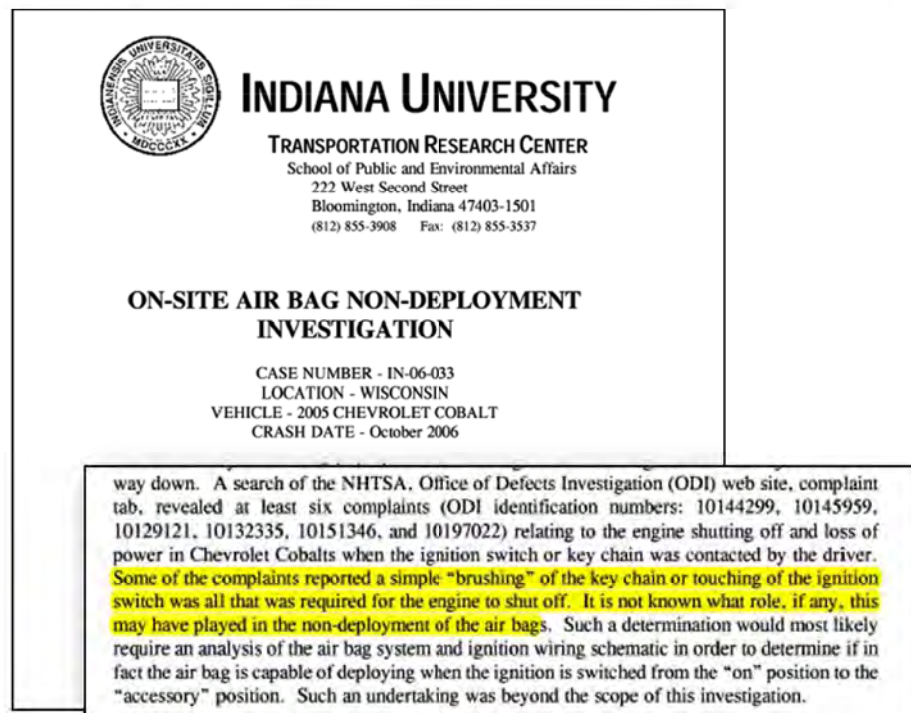
Some of the complaints reported a simple “brushing” of the key chain or touching of the ignition switch was all that was required for the engine to shut off.⁵¹⁹ The researchers concluded:

It is not known what role, if any, this may have played in the non-deployment of the air bags. Such a determination would most likely require an analysis of the air bag system and ignition wiring schematic in order to determine if in fact the air bag is capable of deploying when the ignition is switched from the ‘on’ position to the ‘accessory’ position.⁵²⁰
